FIELD INVESTIGATION SURVEY OF
AIR TIGHTNESS, AIR MOVEMENT
AND INDOOR AIR QUALITY IN
HIGH-RISE APARTMENT BUILDINGS
ATLANTIC REGION

E.W. Scott Bennett, P. Eng.
BFL Consultants Limited
P.O. Box 12070
St. John's, Newfoundland
A1B 3T5

BFL Reference No.: 600-01

Date: 1991 04 30

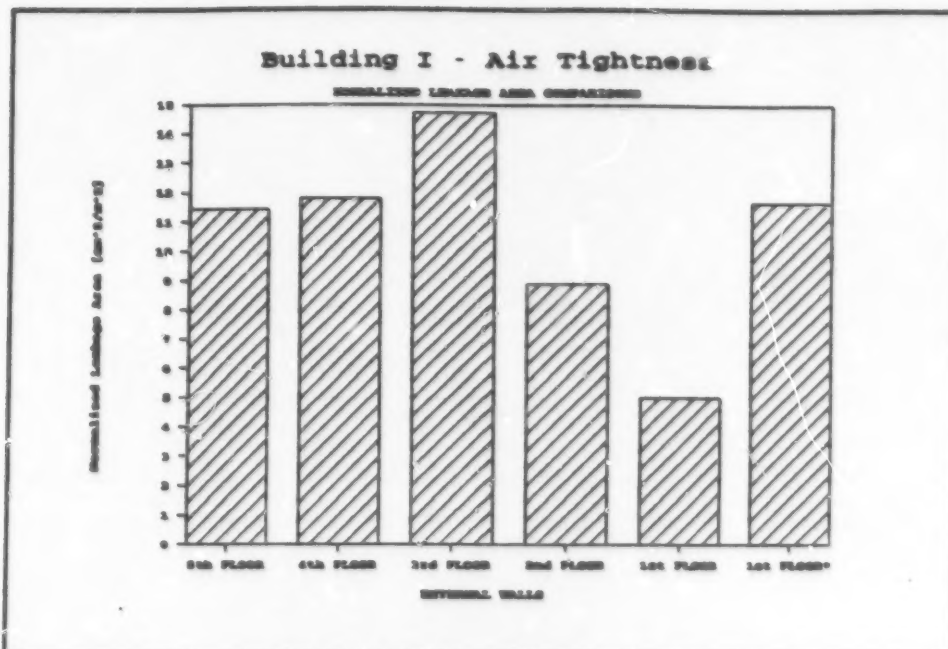
An alternative method used to compare air tightness of the exterior walls was to calculate the normalized leakage area of each level's exterior walls. These results are illustrated in Figure 2. Again the comparison of the results indicates that the air tightness of the first, fourth, and fifth levels are very similar. These results also indicated that the air tightness for the second and third levels varied considerably from the air tightness of the other stories.

Figure 2: Comparison using normalized leakage areas echoes the results determined using normalized flow rates.

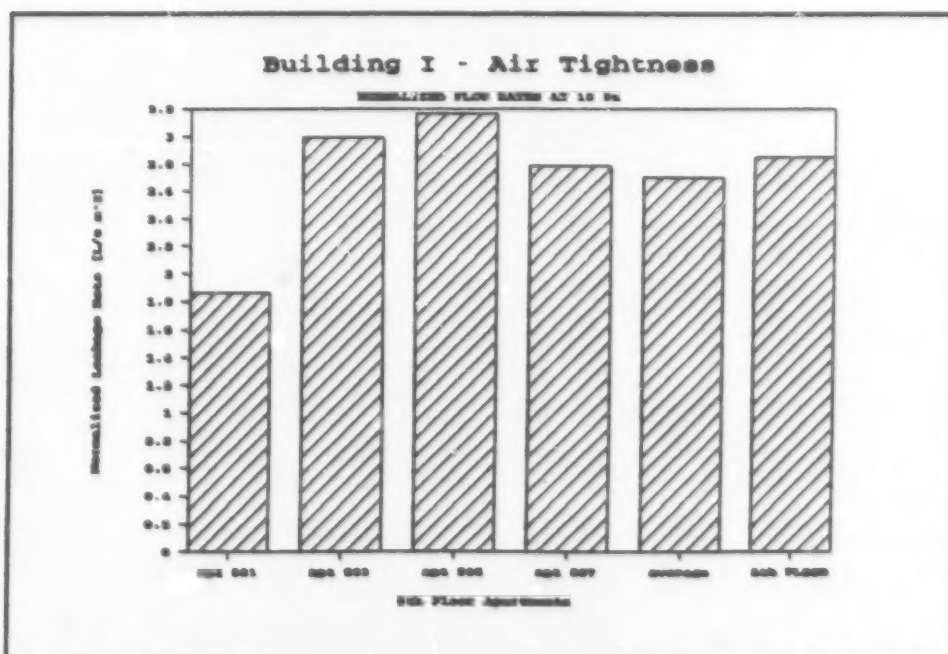
Figure 3: The average determined for the apartments compares well with the normalized flow already determined for the 5th floor.

The normalized flow rates at an exterior pressure differential of 10 Pa was determined for each apartment. These were averaged and compared to the normalized flow rate already determined for the fifth level. The results of this appear in Figure 3. It is evident that the average normalized flow determined from half the apartments on the story corresponds quite closely to the normalized flow determined for the story as a whole.

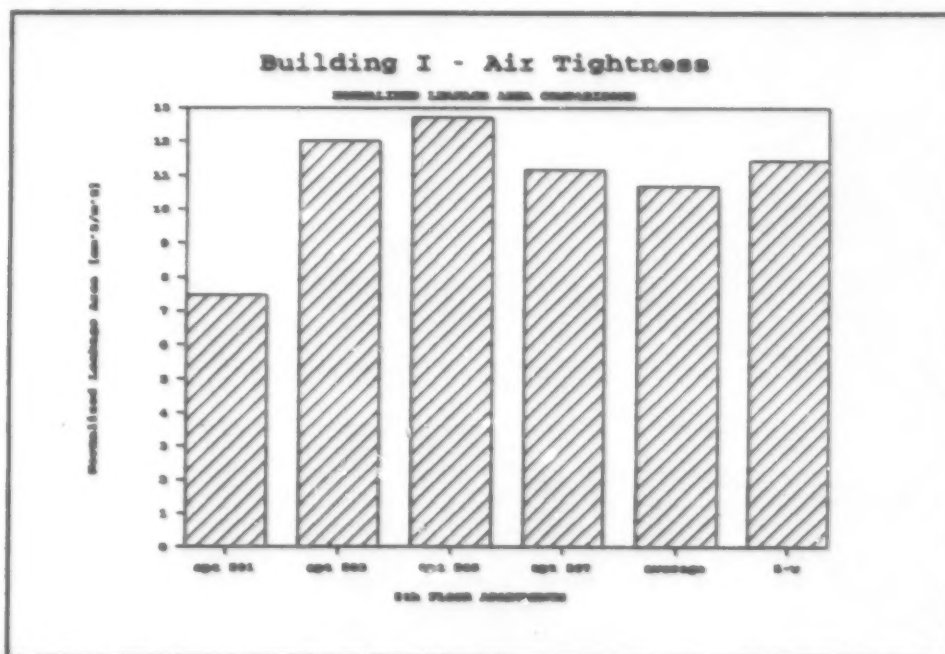
This indicates that the assumption of a 5% slab leakage is quite reasonable in this case. These results are echoed when normalized leakage areas were determined and compared in Figure 4.

Figure 4: Comparison using normalized leakage area echoes the results determined using normalized flow rates.

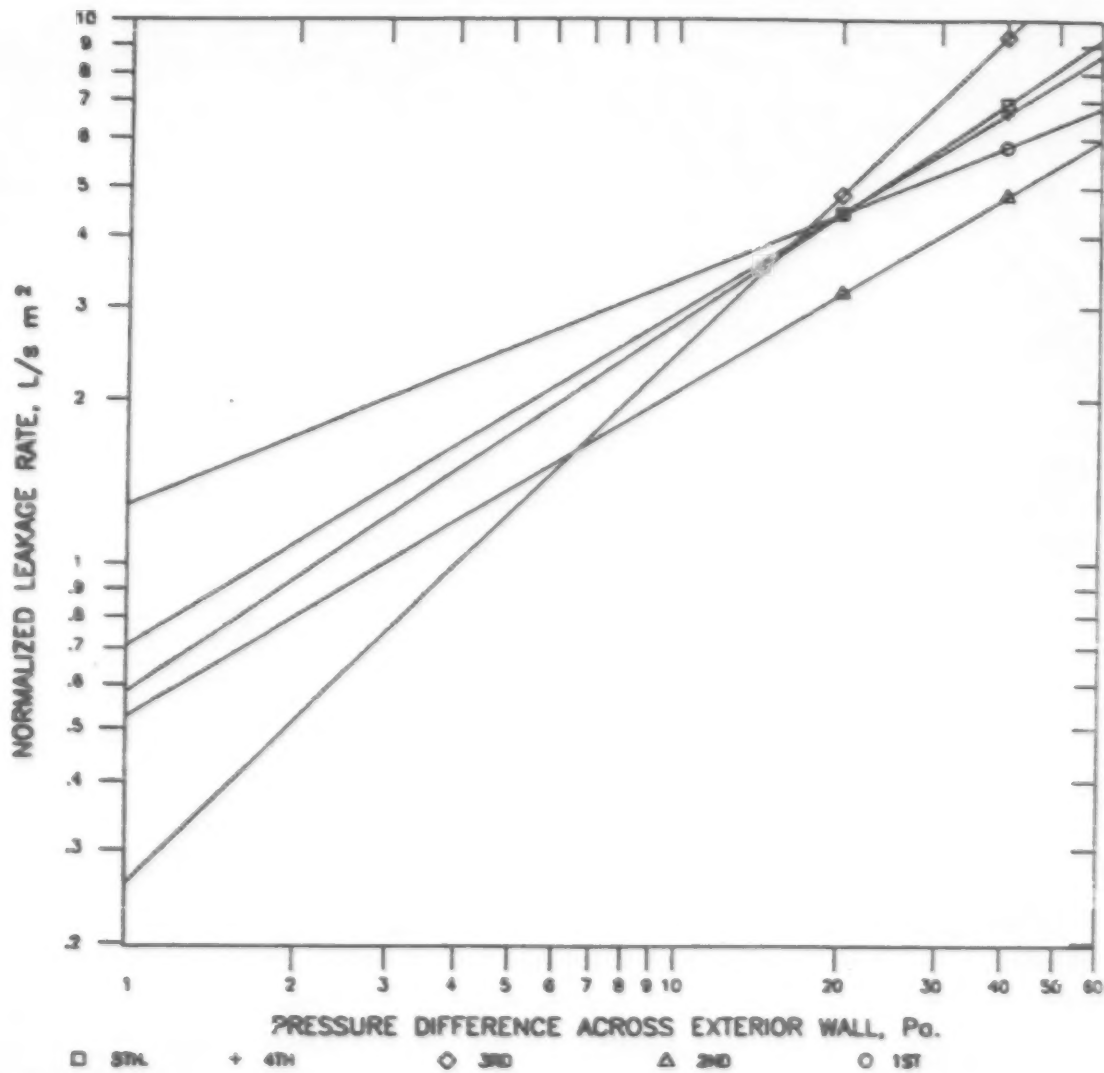
BUILDING I - AIR TIGHTNESS 5TH. FLOOR - EXTERNAL WALLS

FIGURE 5: THIS CLEARLY SHOWS HOW SOME FLOOR'S LEAKAGE RATES ARE QUITE CLOSE TO EACH OTHER WHILE OTHER FLOOR'S LEAKAGE RATES VARY CONSIDERABLY.

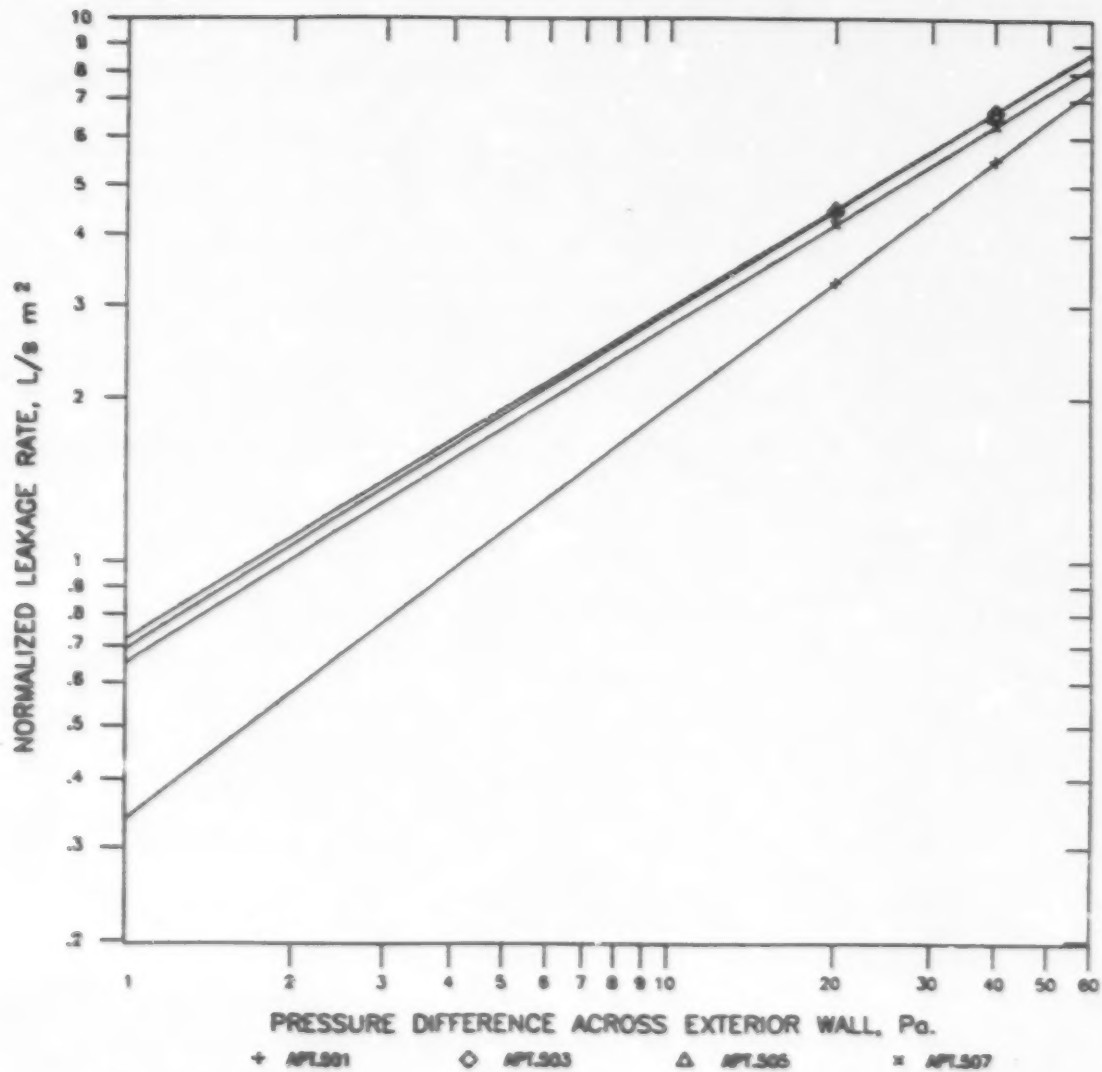
BUILDING I - AIR TIGHTNESS 5TH. FLOOR - EXTERNAL WALLS

FIGURE 8: THIS INDICATES THAT EVEN ON THE SAME FLOOR, SOME GREAT VARIANCE MAY OCCUR WITHIN THE SAME BUILDING COMPONENT.

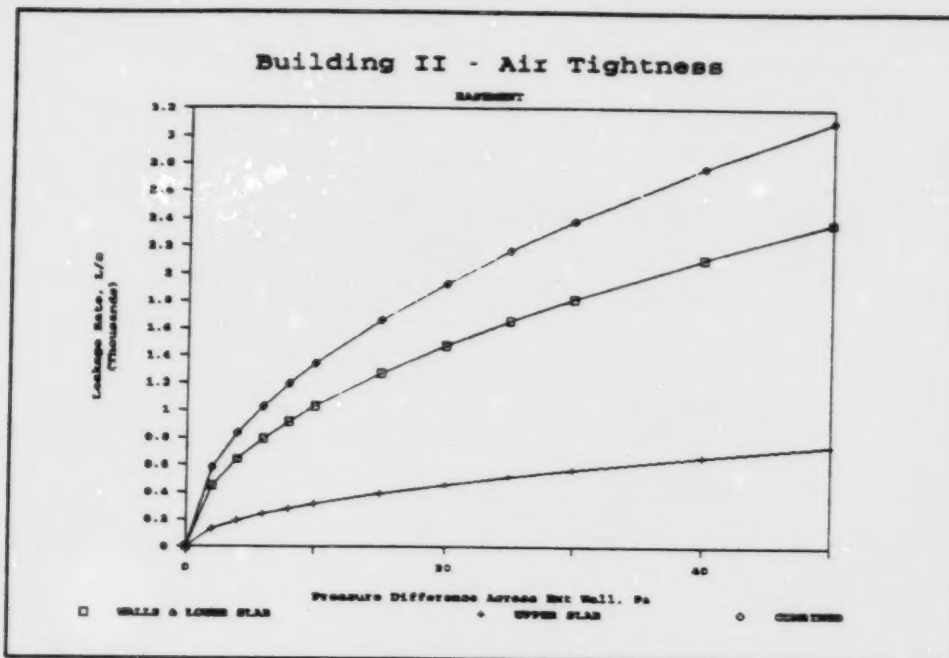
Figure 1: The component leakage rates which have been determined may be combined to get a total leakage rate for the floor.

This flow through the common portion of the first floor lower slab is also the flow through the upper slab of the basement. By combining this with the flow measured from the first test (B-W,LS), the total flow for the basement was determined. This is illustrated in Figure 1 which was shown previously.

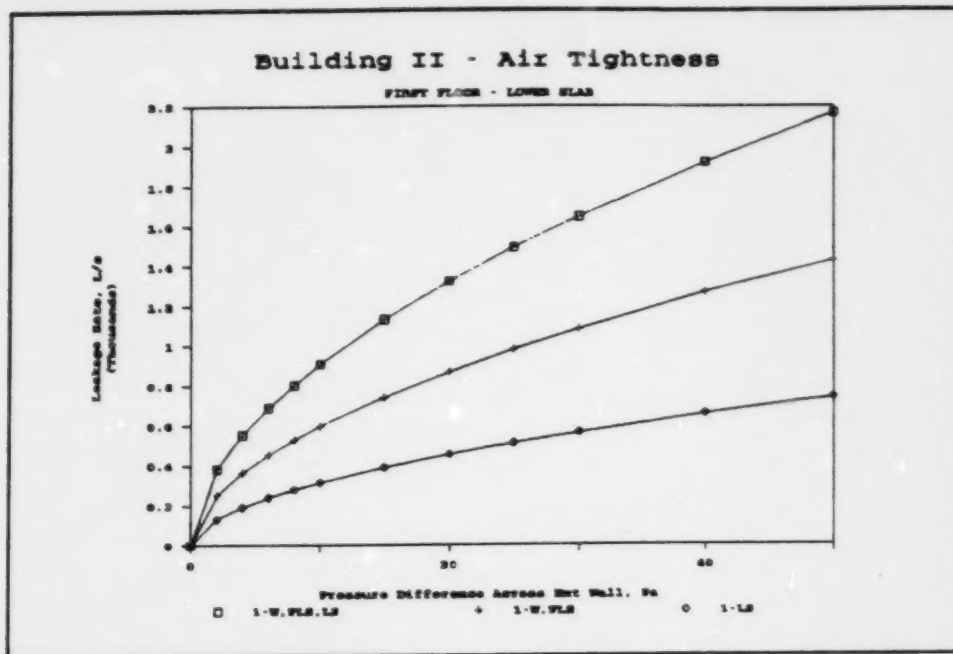
A paper test using the representative equations was then conducted whereby the flows from the second test (1-W,PLS) were subtracted from the flows from the third test (1-W,PLS,LS). By using the test data in this manner, the flow associated with the portion of the first floor's lower slab shared by the basement was isolated. These results are tabulated under 1-LS. Figure 2 illustrates graphically the resulting curves from these tests.

Figure 2: The flow through the lower slab is determined by subtracting the flow through walls and partial lower slab only from the combined flow with the lower slab included.

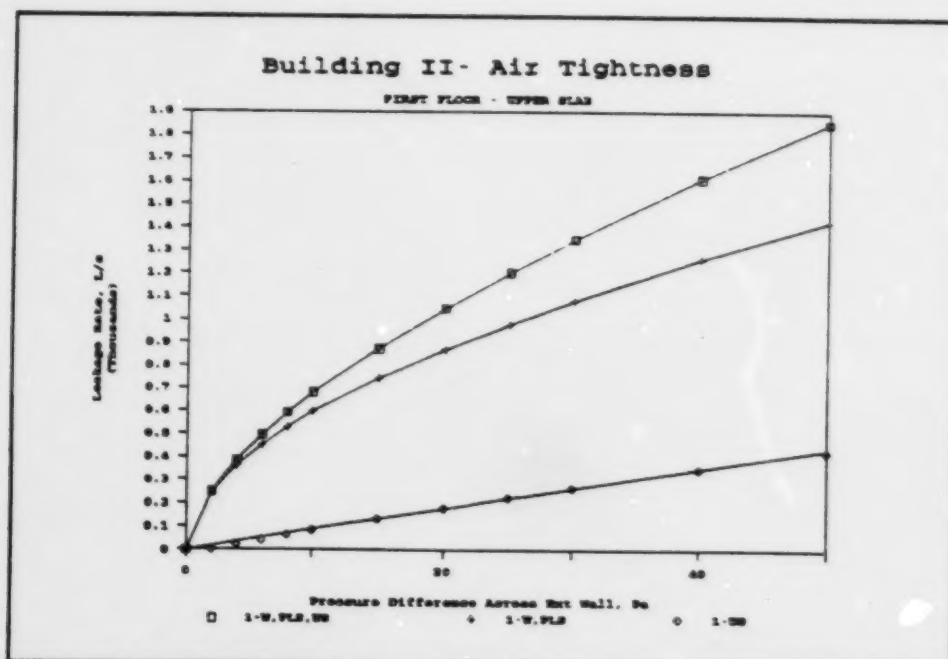
A paper test using representative equations was then conducted whereby the flows from test 1-W,PLS were subtracted from the flows from 1-W,PLS,US. In this manner the flow associated with the upper slab shared by the first and the second floors could be isolated at each given external wall pressure differential. These results are tabulated under 1-US and are illustrated in Figure 3.

Figure 3: The flow through the upper slab is determined by subtracting the flow through the walls and partial lower slab only from the combined flow with the upper slab included.

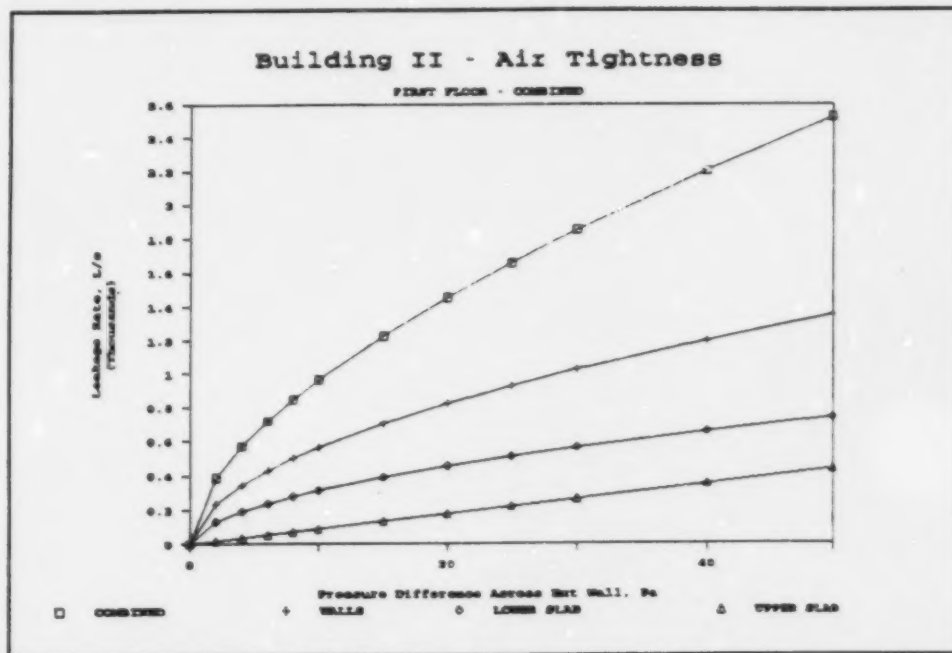
In this manner the flow for each component of the first floor was determined. The total flow for the floor can be determined by combining these components. This is illustrated in Figure 4. When studying this figure it must be remembered that the walls component also includes that portion of the lower slab which could not be balanced. This does not imply, however, that the leakage rate through the unbalanced portion of the lower slab is the same as the leakage rate through the walls. One cannot be isolated from the other thus the combined flow is illustrated under the single heading of walls.

Figure 4: By combining the component leakage rates, a leakage rate for the entire floor may be determined.

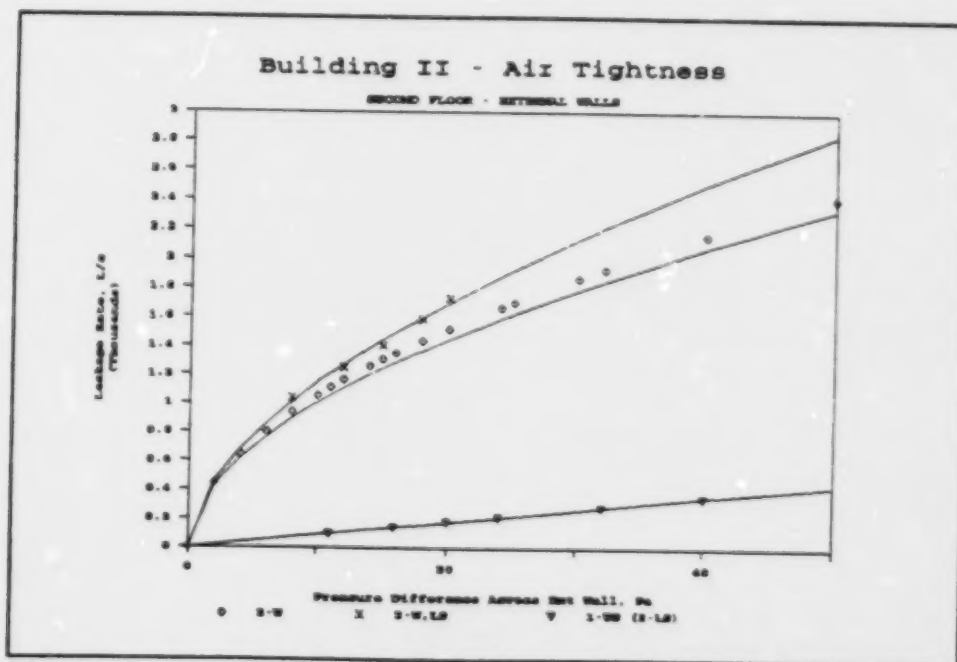
Since the first floor upper slab is the same as the second floor lower slab, the first floor upper slab flow, which was already established, was used to determine the second floor external wall flow. This was achieved by conducting a "paper test" whereby the first floor upper slab flow rates (1-US) were subtracted from the second floor combined walls and lower slab flow rates (2-W,LS) at specified external wall pressure differentials. These results are tabulated under 2-W and are illustrated by Figure 5.

Figure 5: The second floor external wall leakage rate can be determined by subtracting the first floor upper slab (second floor lower slab) leakage rate from the combined second floor and lower slab leakage rate.

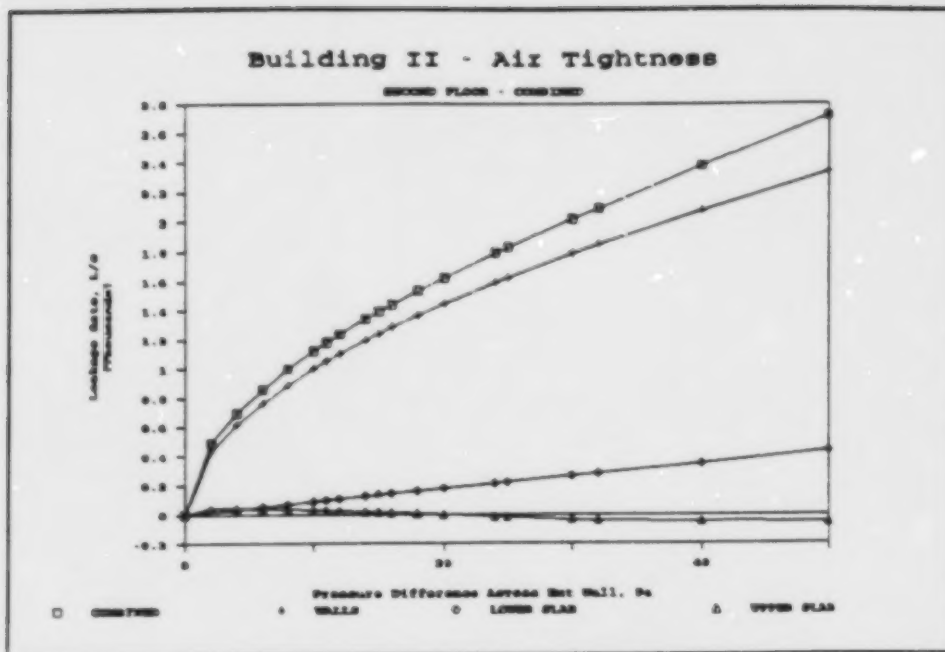
Figure 6: The equation determined to represent the third floor lower slab creates problems when it is used to calculate the second floor's overall flow.

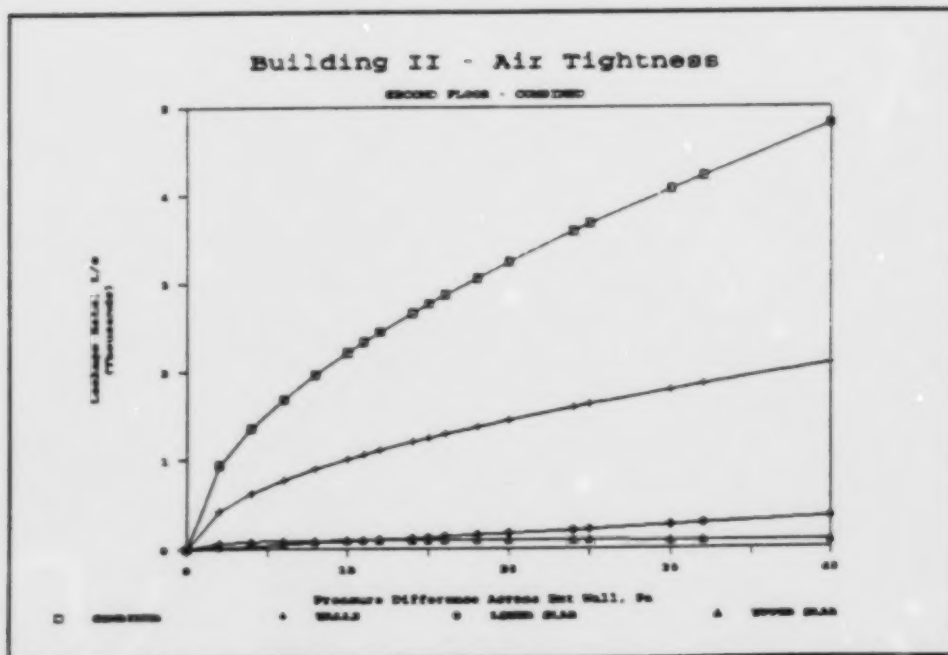
Figure 6B: Better overall results are achieved when the actual measured values for the third floor lower slab's flow are used to determine the second floor's overall flow.

The problems encountered in determining the third floor lower slab flows have an effect on the calculations for the second floor since the third floor lower slab flow is also the second floor upper slab flow. Figures 6 and 6B illustrate the effect the third floor lower slab representation has on the second floor total flow calculations. In order to maintain a curve which conforms to the accepted shape of a flow curve, the actual flow differences between 3-W,LS and 3-W were used to represent the flows through the second-to-third-floor slab.

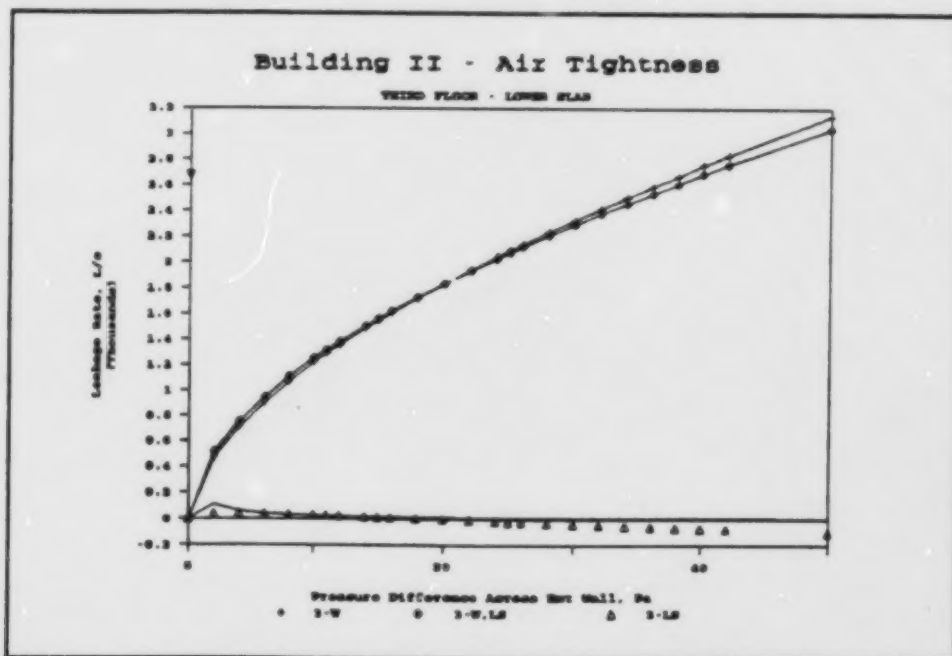
Figure 7: The differences between the measured flows are so small that the calculated equation for the third floor lower slab is not representative of the common flow equation.

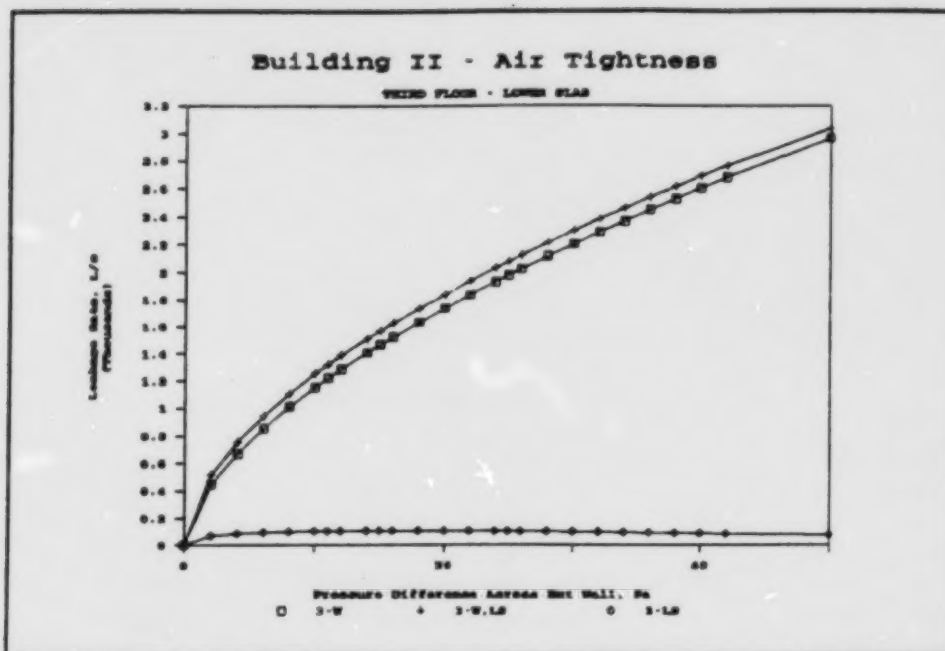
Figure 7B: When the actual subtracted values are plotted, a curve corresponding more closely to the common flow equation results.

In order to compensate for this, the actual flow differences at specified pressure differentials were used in the calculations. As can be seen from Figure 7B, this provided a much better representation of the flow through the third floor lower slab.

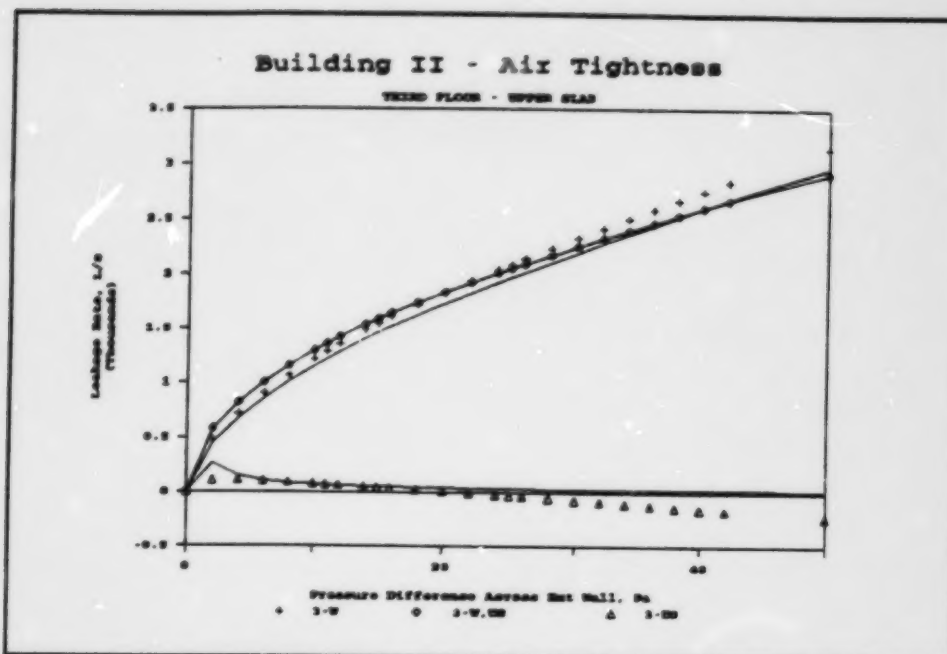
Figure 8: The measured flows are so close together that the calculated equation for the third floor upper slab is not representative of the common flow equation.

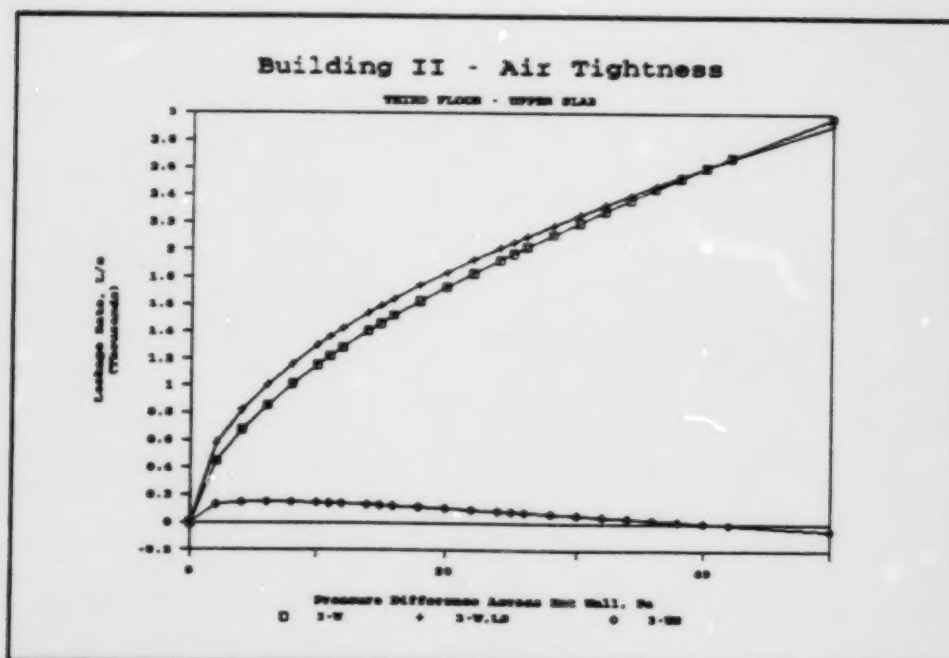
Another test was conducted on the third floor whereby the second-to-third-floor pressure differential was maintained at zero and the combined flow through the third floor external walls and third floor upper slab was measured. The results of this test are tabulated in 3-W,US. A similar problem to that which occurred with the lower slab paper test occurred with the upper slab paper test. The results of this are tabulated under 3-US. Again, the paper test failed the standard although the physical tests both met the standard. In this case, the calculated flows represented a higher percentage of the actual flows. However, these percentages were not great enough to overcome, with any degree of certainty, the inherent errors in the measurement techniques. Again, as illustrated by Figures 8 and 8B, these problems were minimized by using the actual subtracted values rather than a representative equation calculated by the techniques outlined in CAN/CGSB-149.10-M86.

Figure 8B: When the actual subtracted values are plotted, a curve corresponding more closely to the common flow equation results.

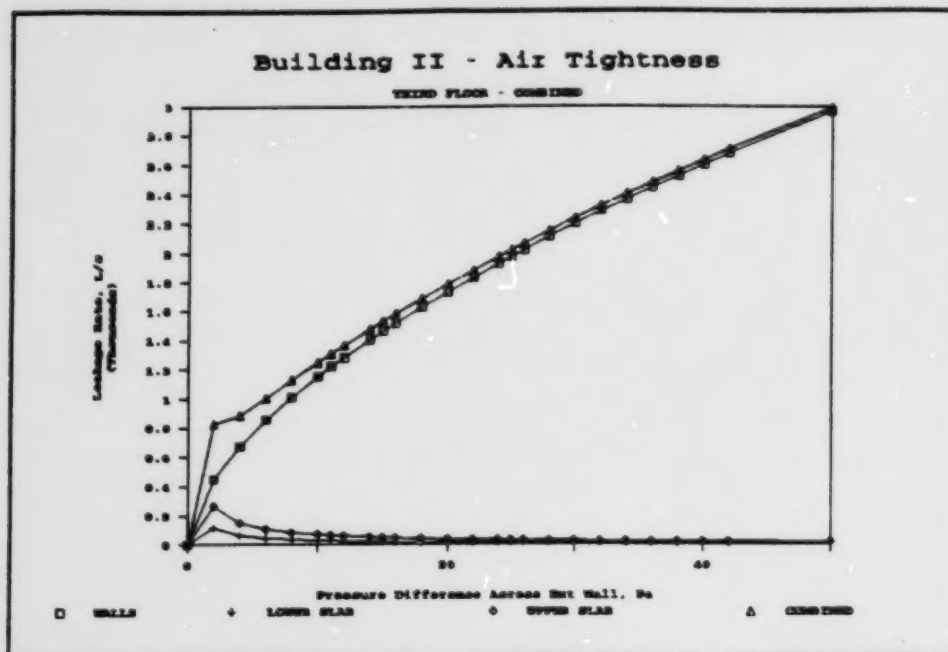
Figure 9: The problems encountered in determining the flow through the slab is clearly echoed in the combined results.

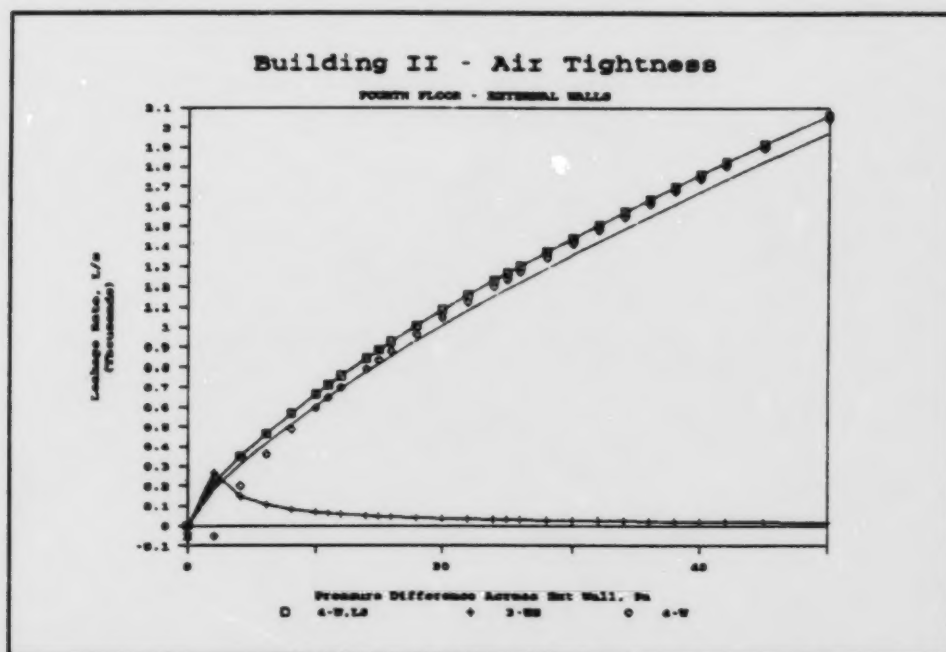
Figure 10:

The influence of the third floor slabs also affects the determination of the fourth floor's external walls.

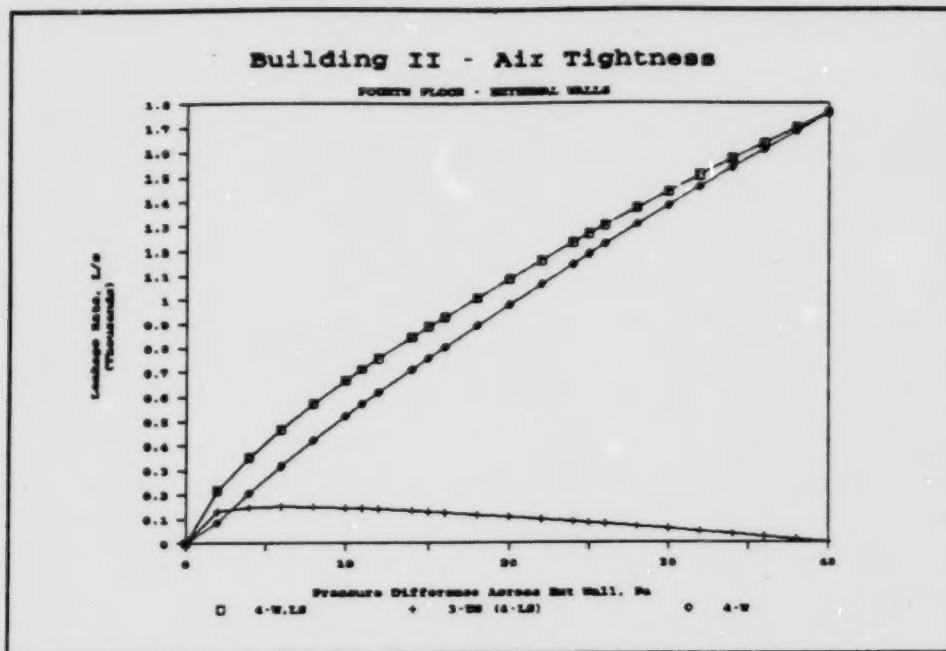
A paper test was then conducted whereby the flow through the third floor upper slab (3-US) was subtracted from the combined flow from the test above (4-W,LS). This is tabulated under test 4-W. In this case, the paper test passed the standard when the estimating equations were used. However, looking at Figure 10, it can be seen that the resulting curve for the wall does not correspond very well to the calculated points. This problem can be linked to the representative equation for the third floor upper slab. If the actual subtracted values for the third floor upper slab flows are used, a better correlation results.

Figure 10B: Using the actual subtracted values for the third floor upper slab results in a more representative flow curve for the fourth floor external walls.

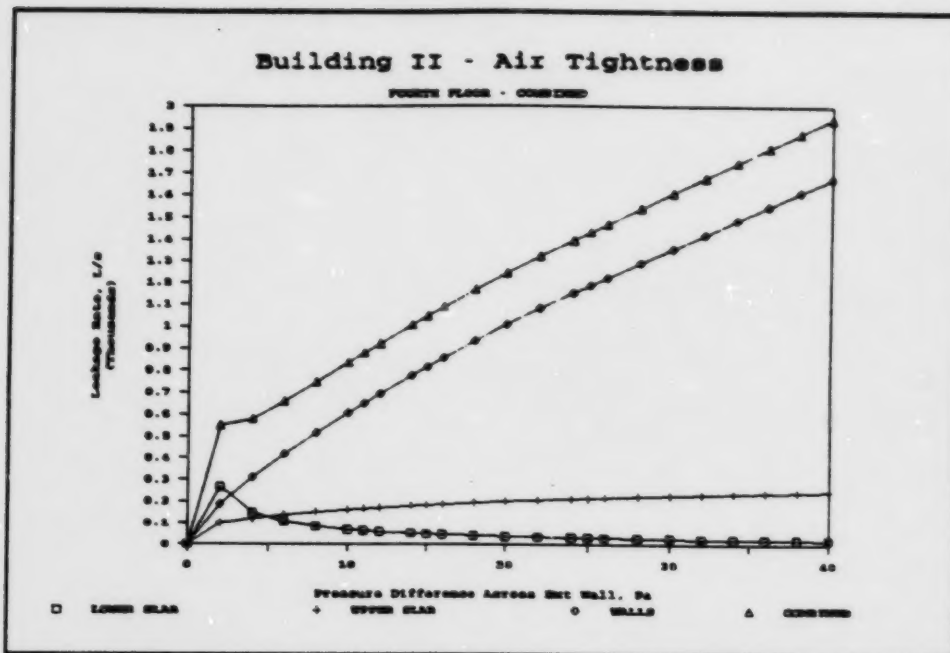
The combined fourth floor results are illustrated in Figure 11 and 11B. Again, it is clear that by using the actual values a more regular representation of the combined flow results.

Figure 11: The flow determined for the third floor upper slab has a definite influence on the flows determined for the fourth floor.

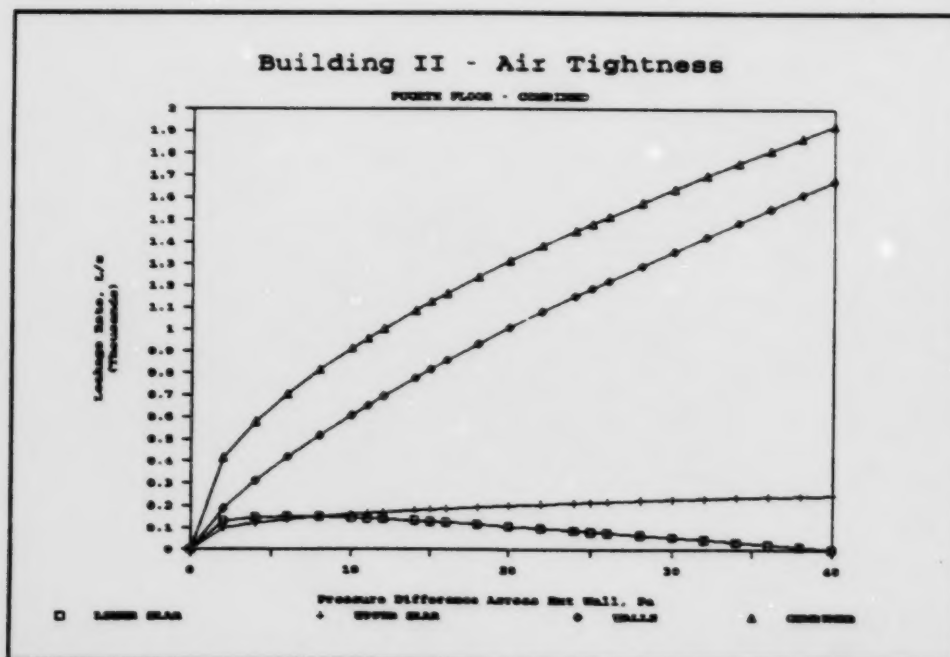
Figure 11B: If the actual subtracted values for third floor results are used, better curves corresponding more closely to common flow equations result on the fourth floor.

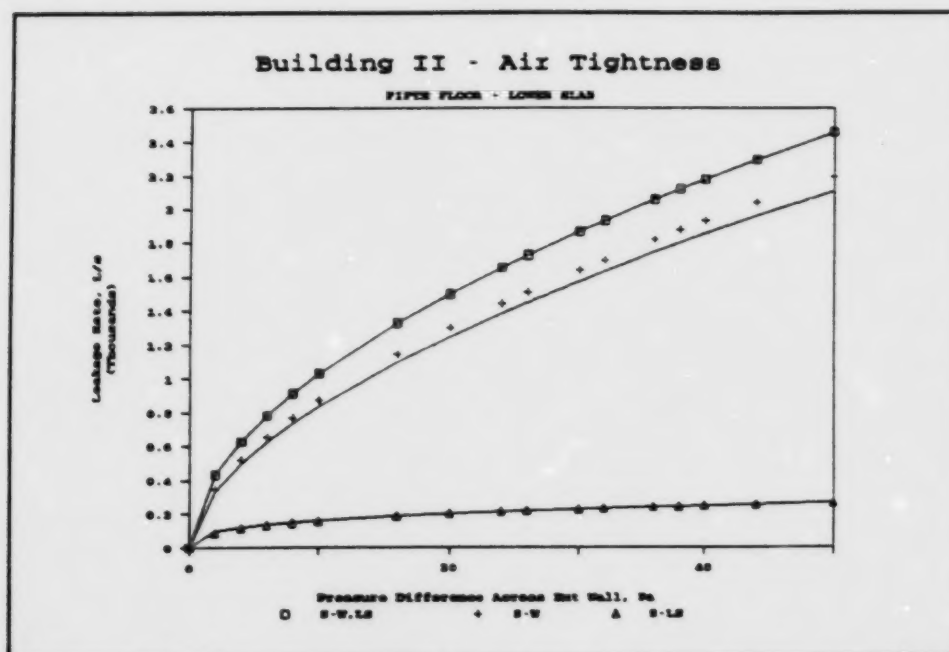
A paper test was then conducted whereby the representative flow equation for the fifth floor wall flow was subtracted from the representative equation of the combined fifth floor walls and lower slab flow at specified pressure differentials. In this manner the flow through the fifth floor lower slab was determined. These results are tabulated in 5-LS and are illustrated in Figure 12.

Figure 12: The flow through the fifth floor lower slab is determined by subtracting the flow through the wall from the combined flow through the walls and lower slab.

As indicated, the test failed to meet the standard because the calculated "n" value did not fall within the required limits. It should be noted that the representative curve did correspond reasonably well with the accepted norm for flow curves and so these representative curve values were used as is.

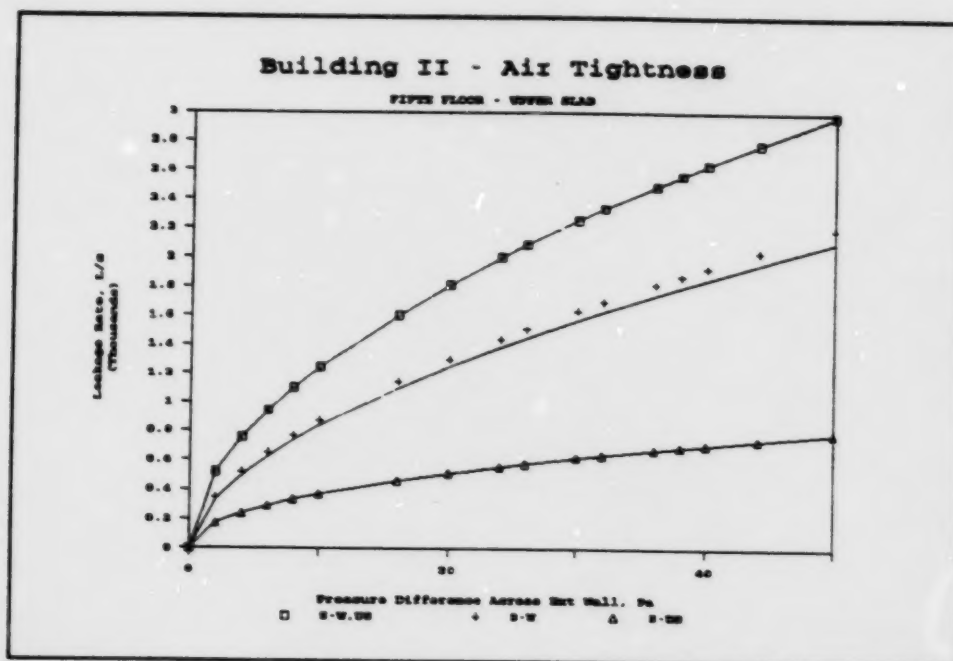
Again a paper test was conducted subtracting the wall flows from the combined flows to determine the flow through the upper slab. These results are tabulated in 5-US. Again the test failed to meet the standard but the graphical representation was close enough to the normal flow curve to be acceptable. These results are illustrated in Figure 13.

Figure 13: The flow through the fifth floor upper slab is determined by subtracting the flow through the wall from the combined flow through the wall and lower slab.

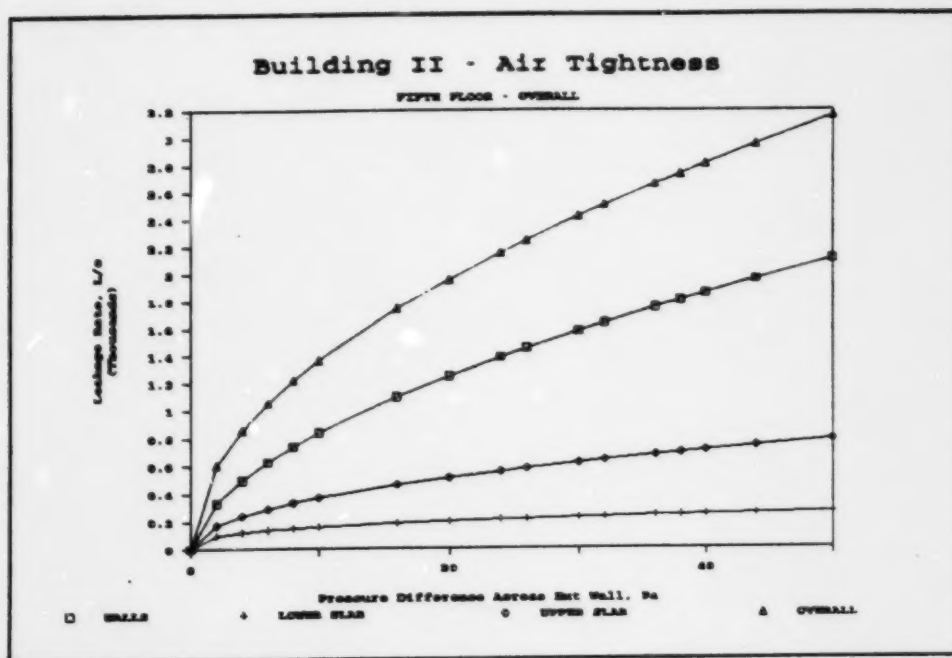
Figure 14: The overall flow is determined by summing the component parts.

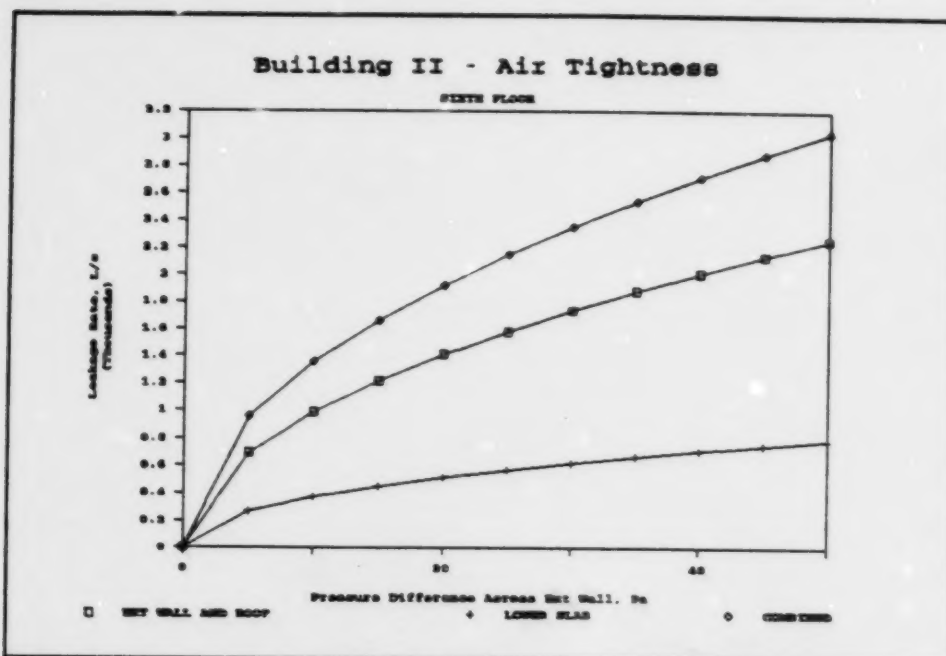
The final test conducted maintained a zero pressure differential between the fifth and sixth floor and measured the flow on the sixth floor. In this case the flow represented the combined flow through the walls and the roof of the sixth floor including the penthouse. This test met the standard. The results are presented in table 6-W,US,PENT and are illustrated in Figure 15.

Figure 15: The overall flow is determined by summing the component parts.

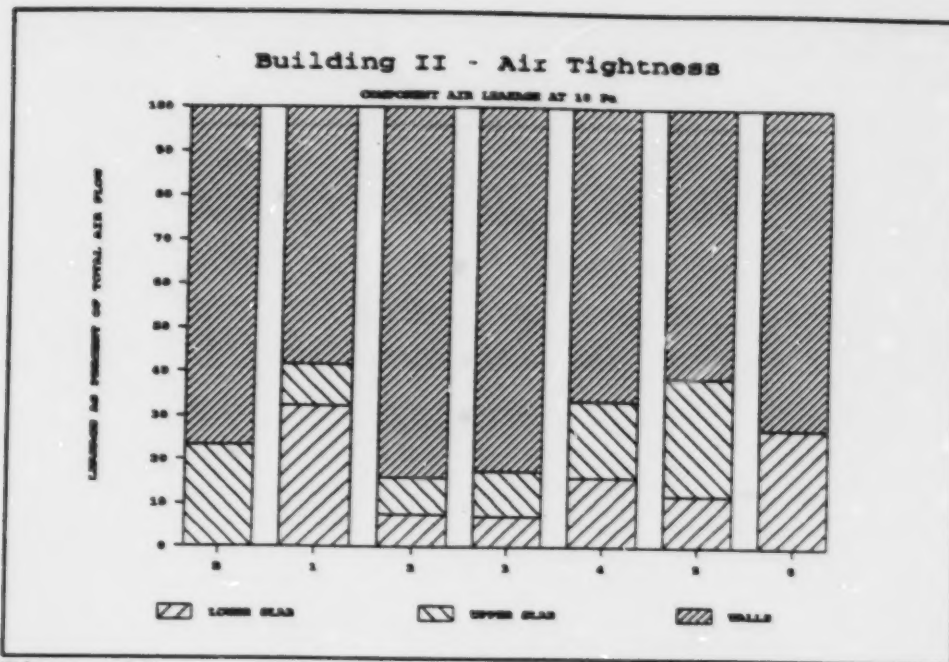
Figure 16: Influence of third floor slabs is relatively small.

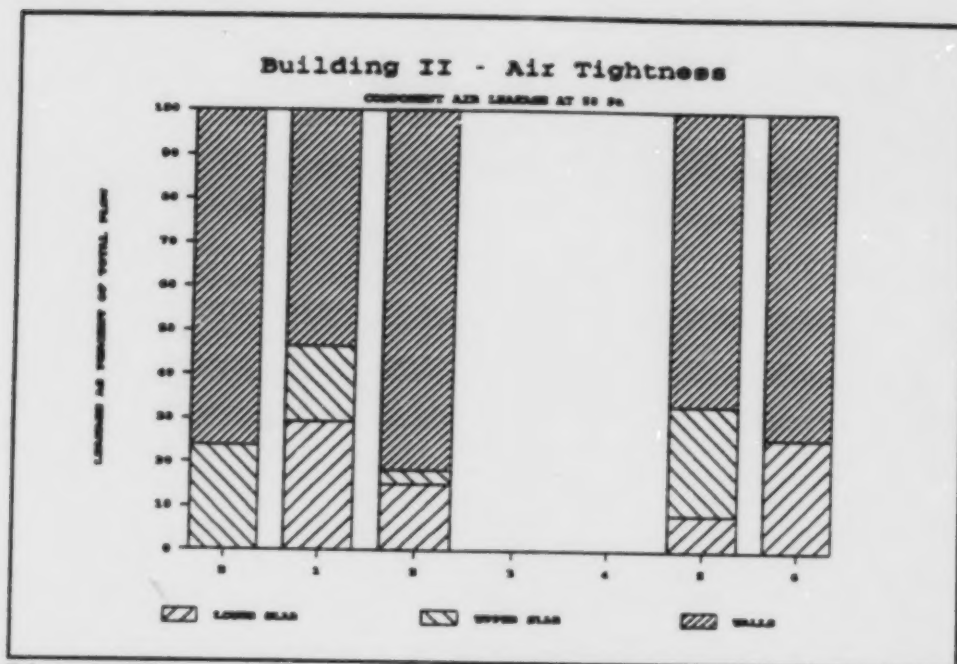
With these factors taken into consideration, it is apparent that the component breakdown of air leakage for the basement, first, fifth and sixth floors, remains relatively constant from pressure to pressure. On the other hand, the second, third, and fourth floors' component breakdown tends to vary substantially from pressure to pressure. In fact, the data for a pressure differential of 50 Pa was so inconsistent that it was not appropriate to attempt to graph it for these floors.

Figure 20: Data for the 3rd and 4th floor is very inconsistent and so is not shown.

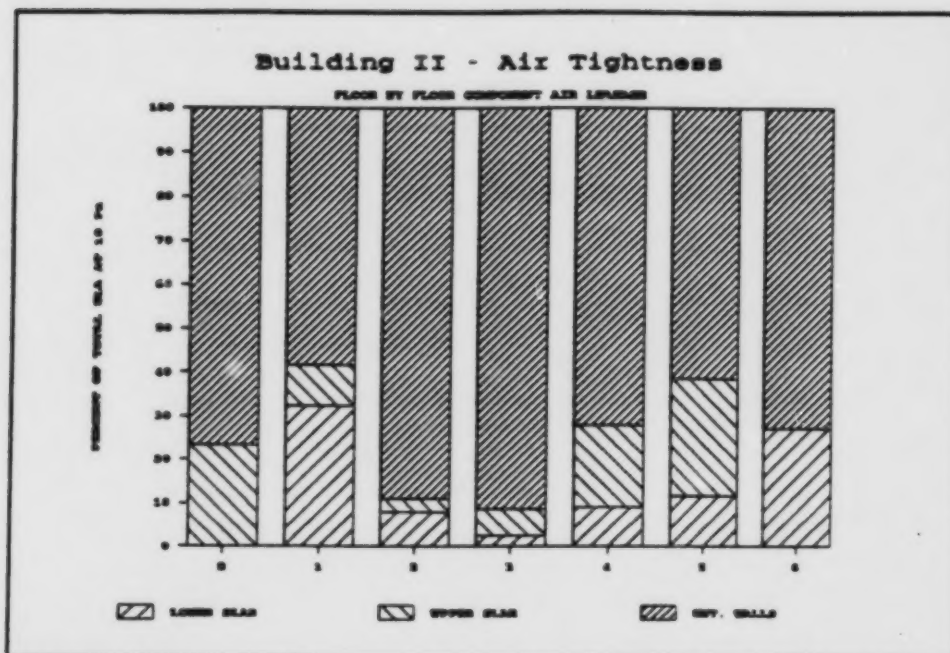
Figure 21: Component air leakage, as determined using ELA, also indicates that the influence of the third floor slabs is relatively small.

The equivalent leakage area of each of the building components was determined. For each floor, the ELA's were totalled and then the ELA of each component was taken as a percent of the total for the floor. When this calculation was performed, it was found that the component influence for the third floor upper and lower slabs corresponded more closely to the component influence of the other slabs. The floor by floor component air leakage, as calculated using ELA is displayed in Figure 21.

Again it can be seen from the figure that the percent participation of each individual component changes from floor to floor. What is particularly notable is that the significance of the leakage through the third floor slabs is relatively small.
